**DEPARTMENT OF TRANSPORTATION**

Contract #: 04-0120F4Cty: SF/ALA Rte: 80 PM: 13.2/13.9File #: 69.28**WELDING INSPECTION REPORT****Resident Engineer:**Pursell, Gary**Address:** 333 Burma Road**City:** Oakland, CA 94607**Report No:** WIR-001266**Date Inspected:** 22-Jan-2008**Project Name:** SAS Superstructure**OSM Arrival Time:** 600**Prime Contractor:** American Bridge/Fluor Enterprises, a JV**OSM Departure Time:** 1630**Contractor:** Zhenhua Port Machinery Company, Ltd (ZPMC), Changxing Island **Location:** Shanghai,China**CWI Name:** Ciu Yi Ru**CWI Present:** Yes No**Inspected CWI report:** Yes No N/A**Rod Oven in Use:** Yes No N/A**Electrode to specification:** Yes No N/A**Weld Procedures Followed:** Yes No N/A**Qualified Welders:** Yes No N/A**Verified Joint Fit-up:** Yes No N/A**Approved Drawings:** Yes No N/A**Approved WPS:** Yes No N/A**Delayed / Cancelled:** Yes No N/A**Bridge No:** 34-0006**Component:** Floor Beam**Summary of Items Observed:**

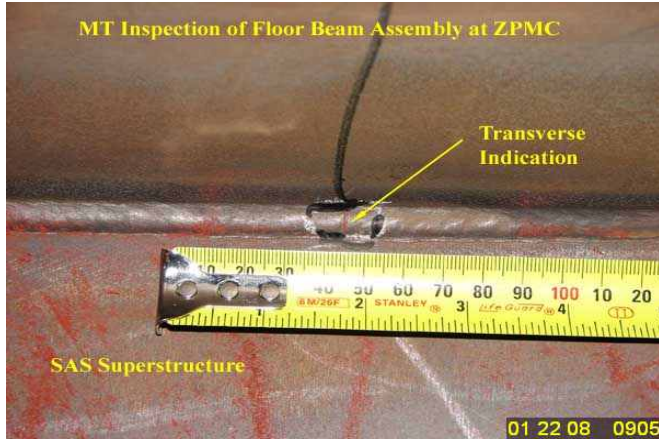
ZPMC Level II MT Inspector Cai Xin Xin completed the MT inspection of 28 floor beam assemblies. Cai Xin Xin found a very large number of transverse cracks on nearly all floor beam assemblies. The transverse cracks were found on completed fillet welds at the junction of the longitudinal and transverse stiffeners to diaphragm plates and flanges to diaphragm plates on the floor beams.

The QA inspector questioned ZPMC Level II MT Inspector Cai Xin Xin if he found transverse cracks in all 28 floor beam assemblies. Cai Xin Xin replied there were approximately 5 floor beam assemblies with no indications and numerous indications were found in all the other assemblies.
